SMITHSONIAN INSTITUTION

Arts & Industries
Building Revitalization

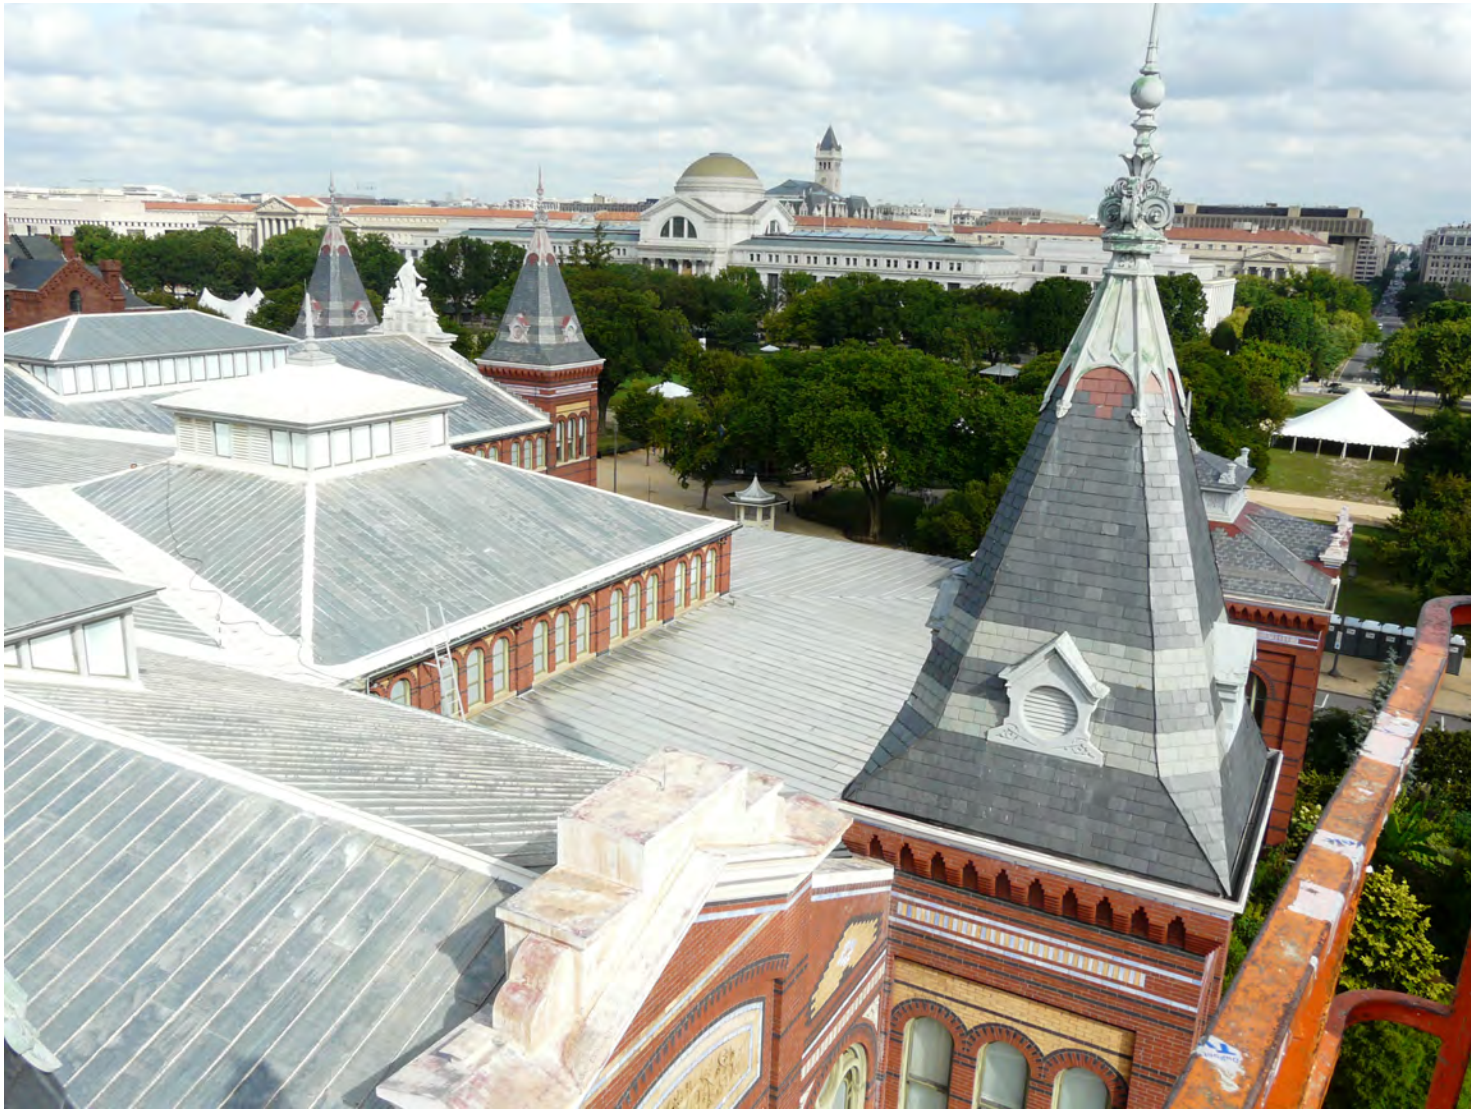
Before Existing condition of a representative roof quadrant looking northwest towards the National Mall.

All roof assemblies were removed down to structure and replaced. Decorative metal elements were repaired, refinished, and reinstalled, and replacements were replicated.

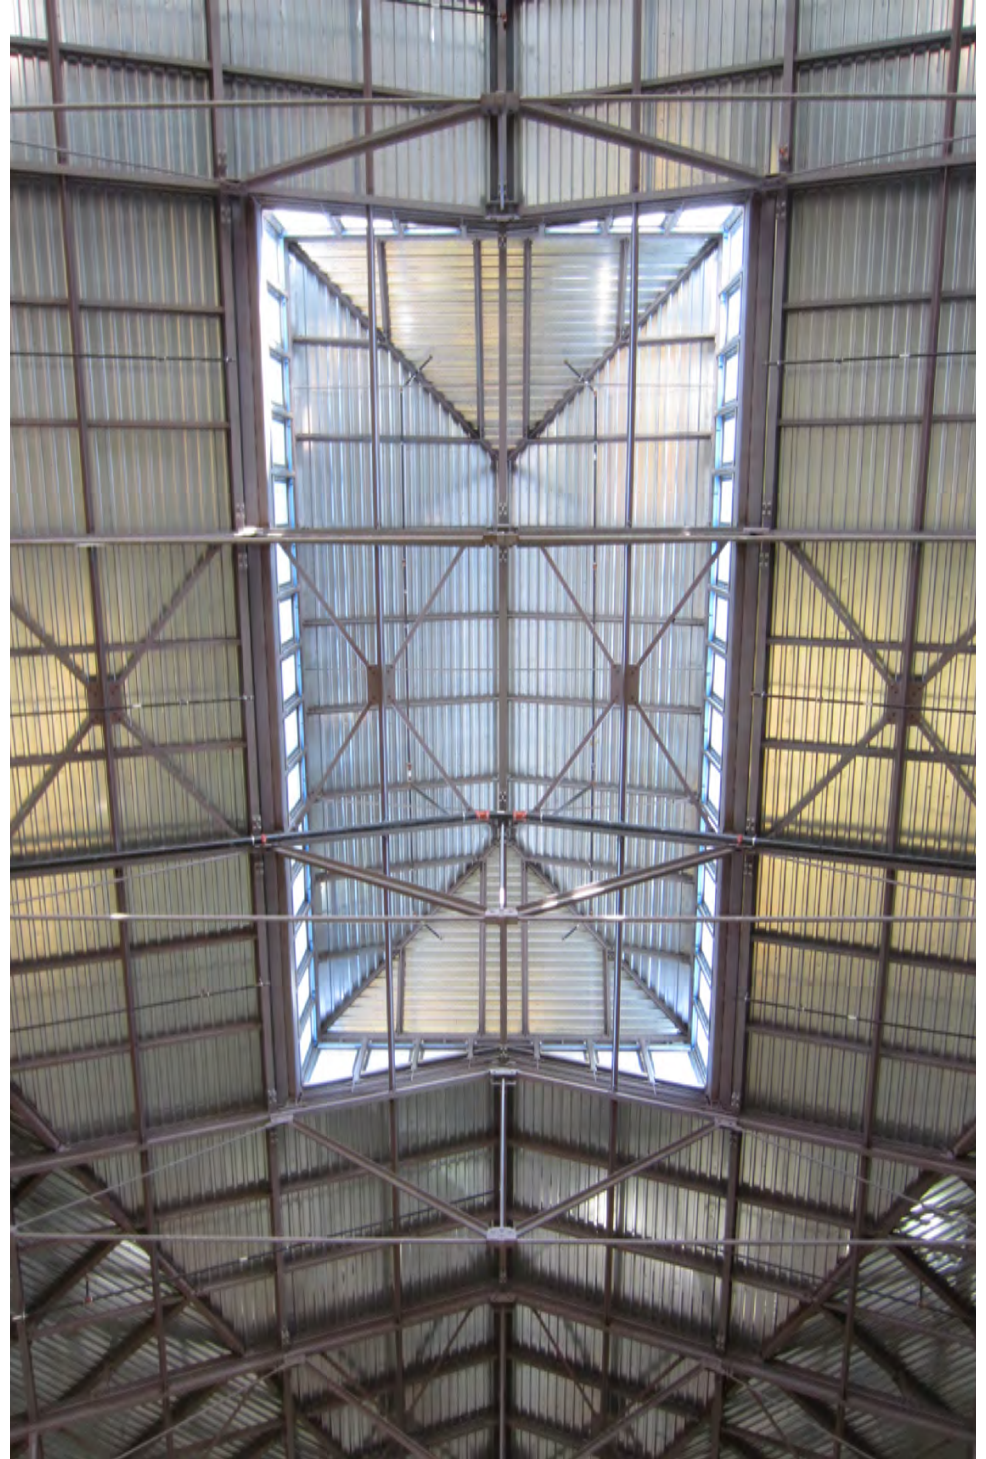
Underside of Hall and Monitor roof after replacement of trusses and metal deck.

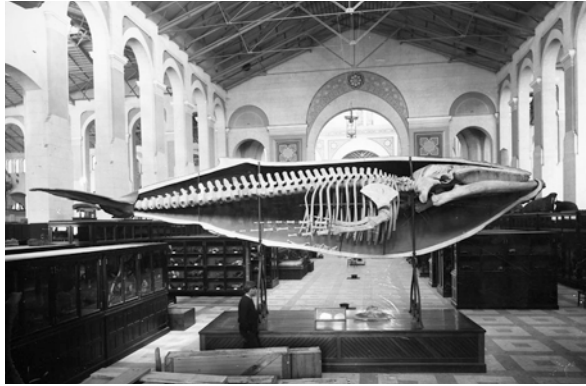
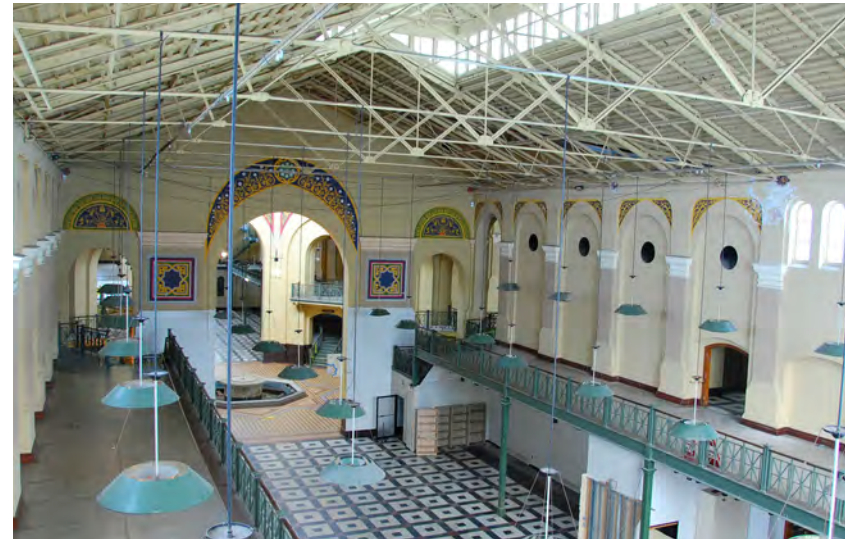
Before Interior photo prior to the start of the project. An example of how infilling between piers/arches compromised the historic spatial character.

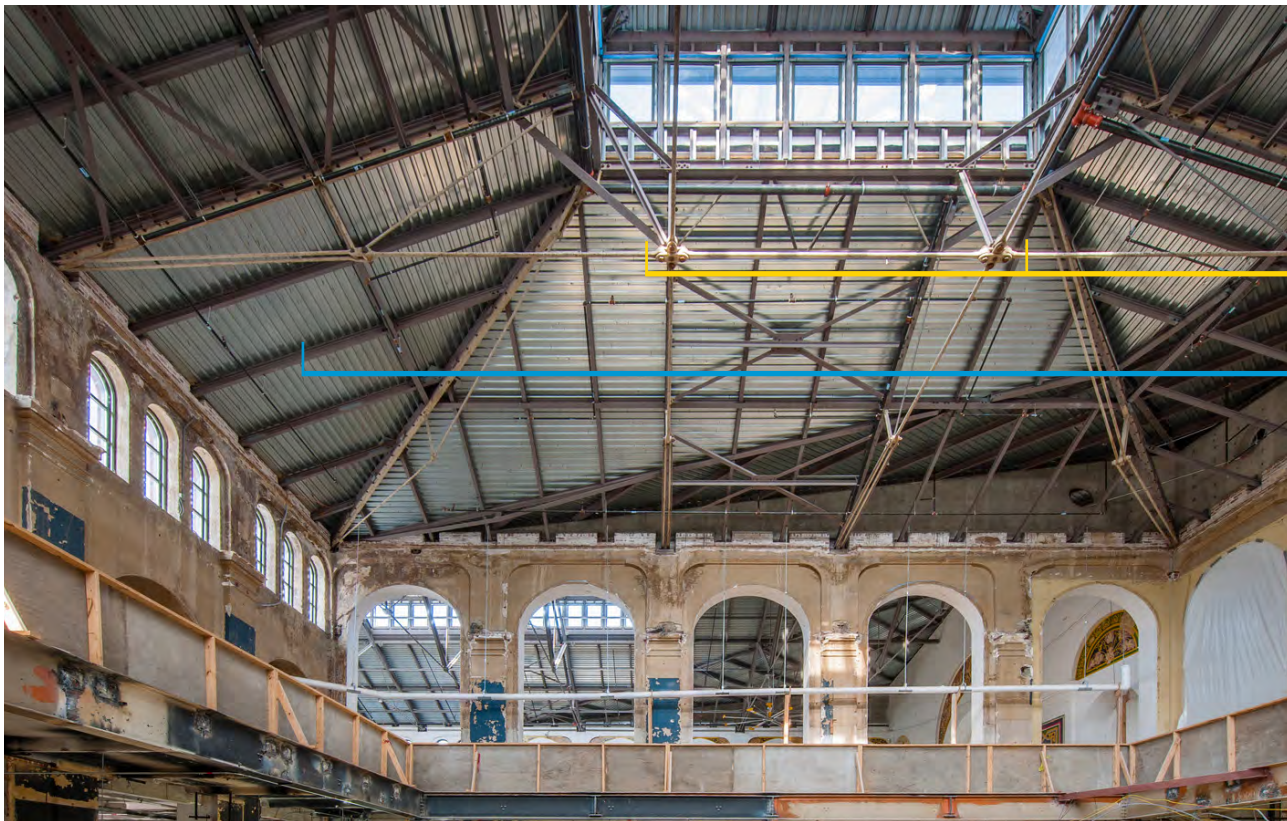
Southeast Court Looking west during shell renovation. Original gallery construction is visible on all three sides. The new roof structure is dark gray and the original members are light tan. At this location one can observe the monitor in both the Court and South Hall beyond. Truss and purlin pockets are visible at the top of the brick wall.

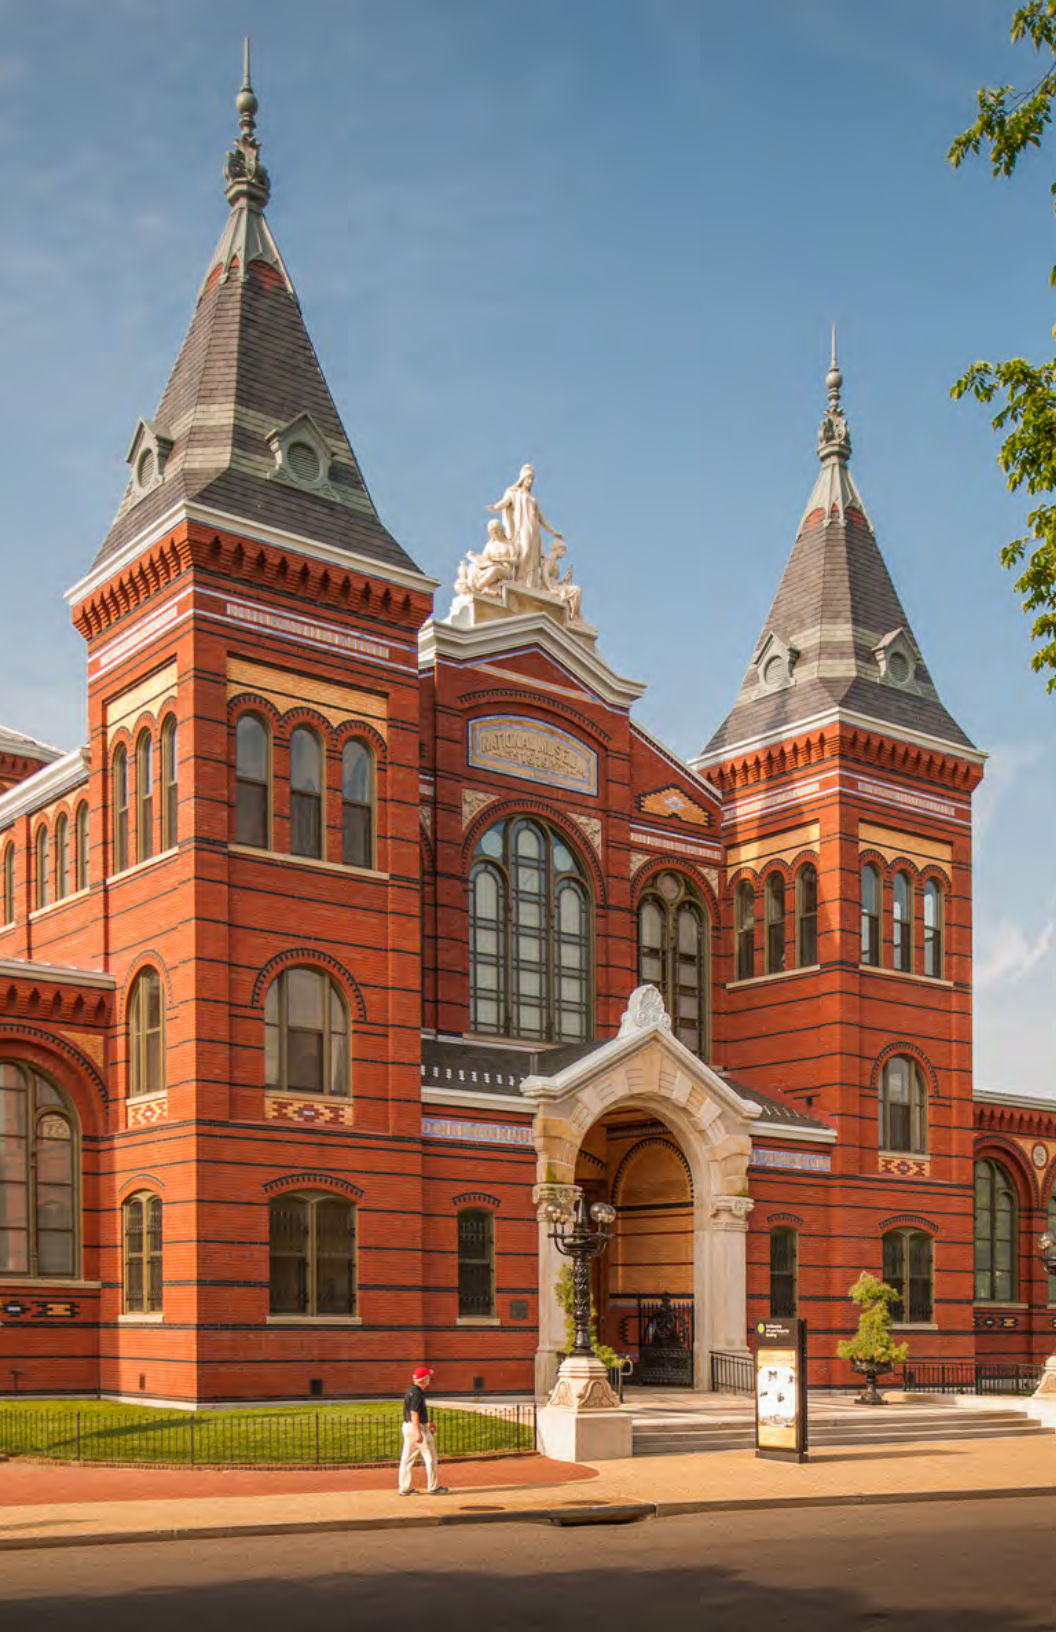
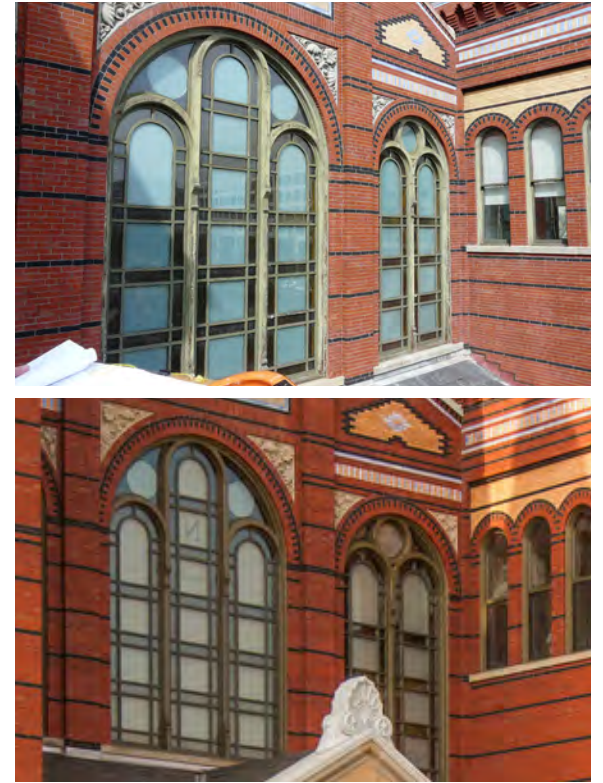
Before & After Closeup views of the polychrome brick and windows.

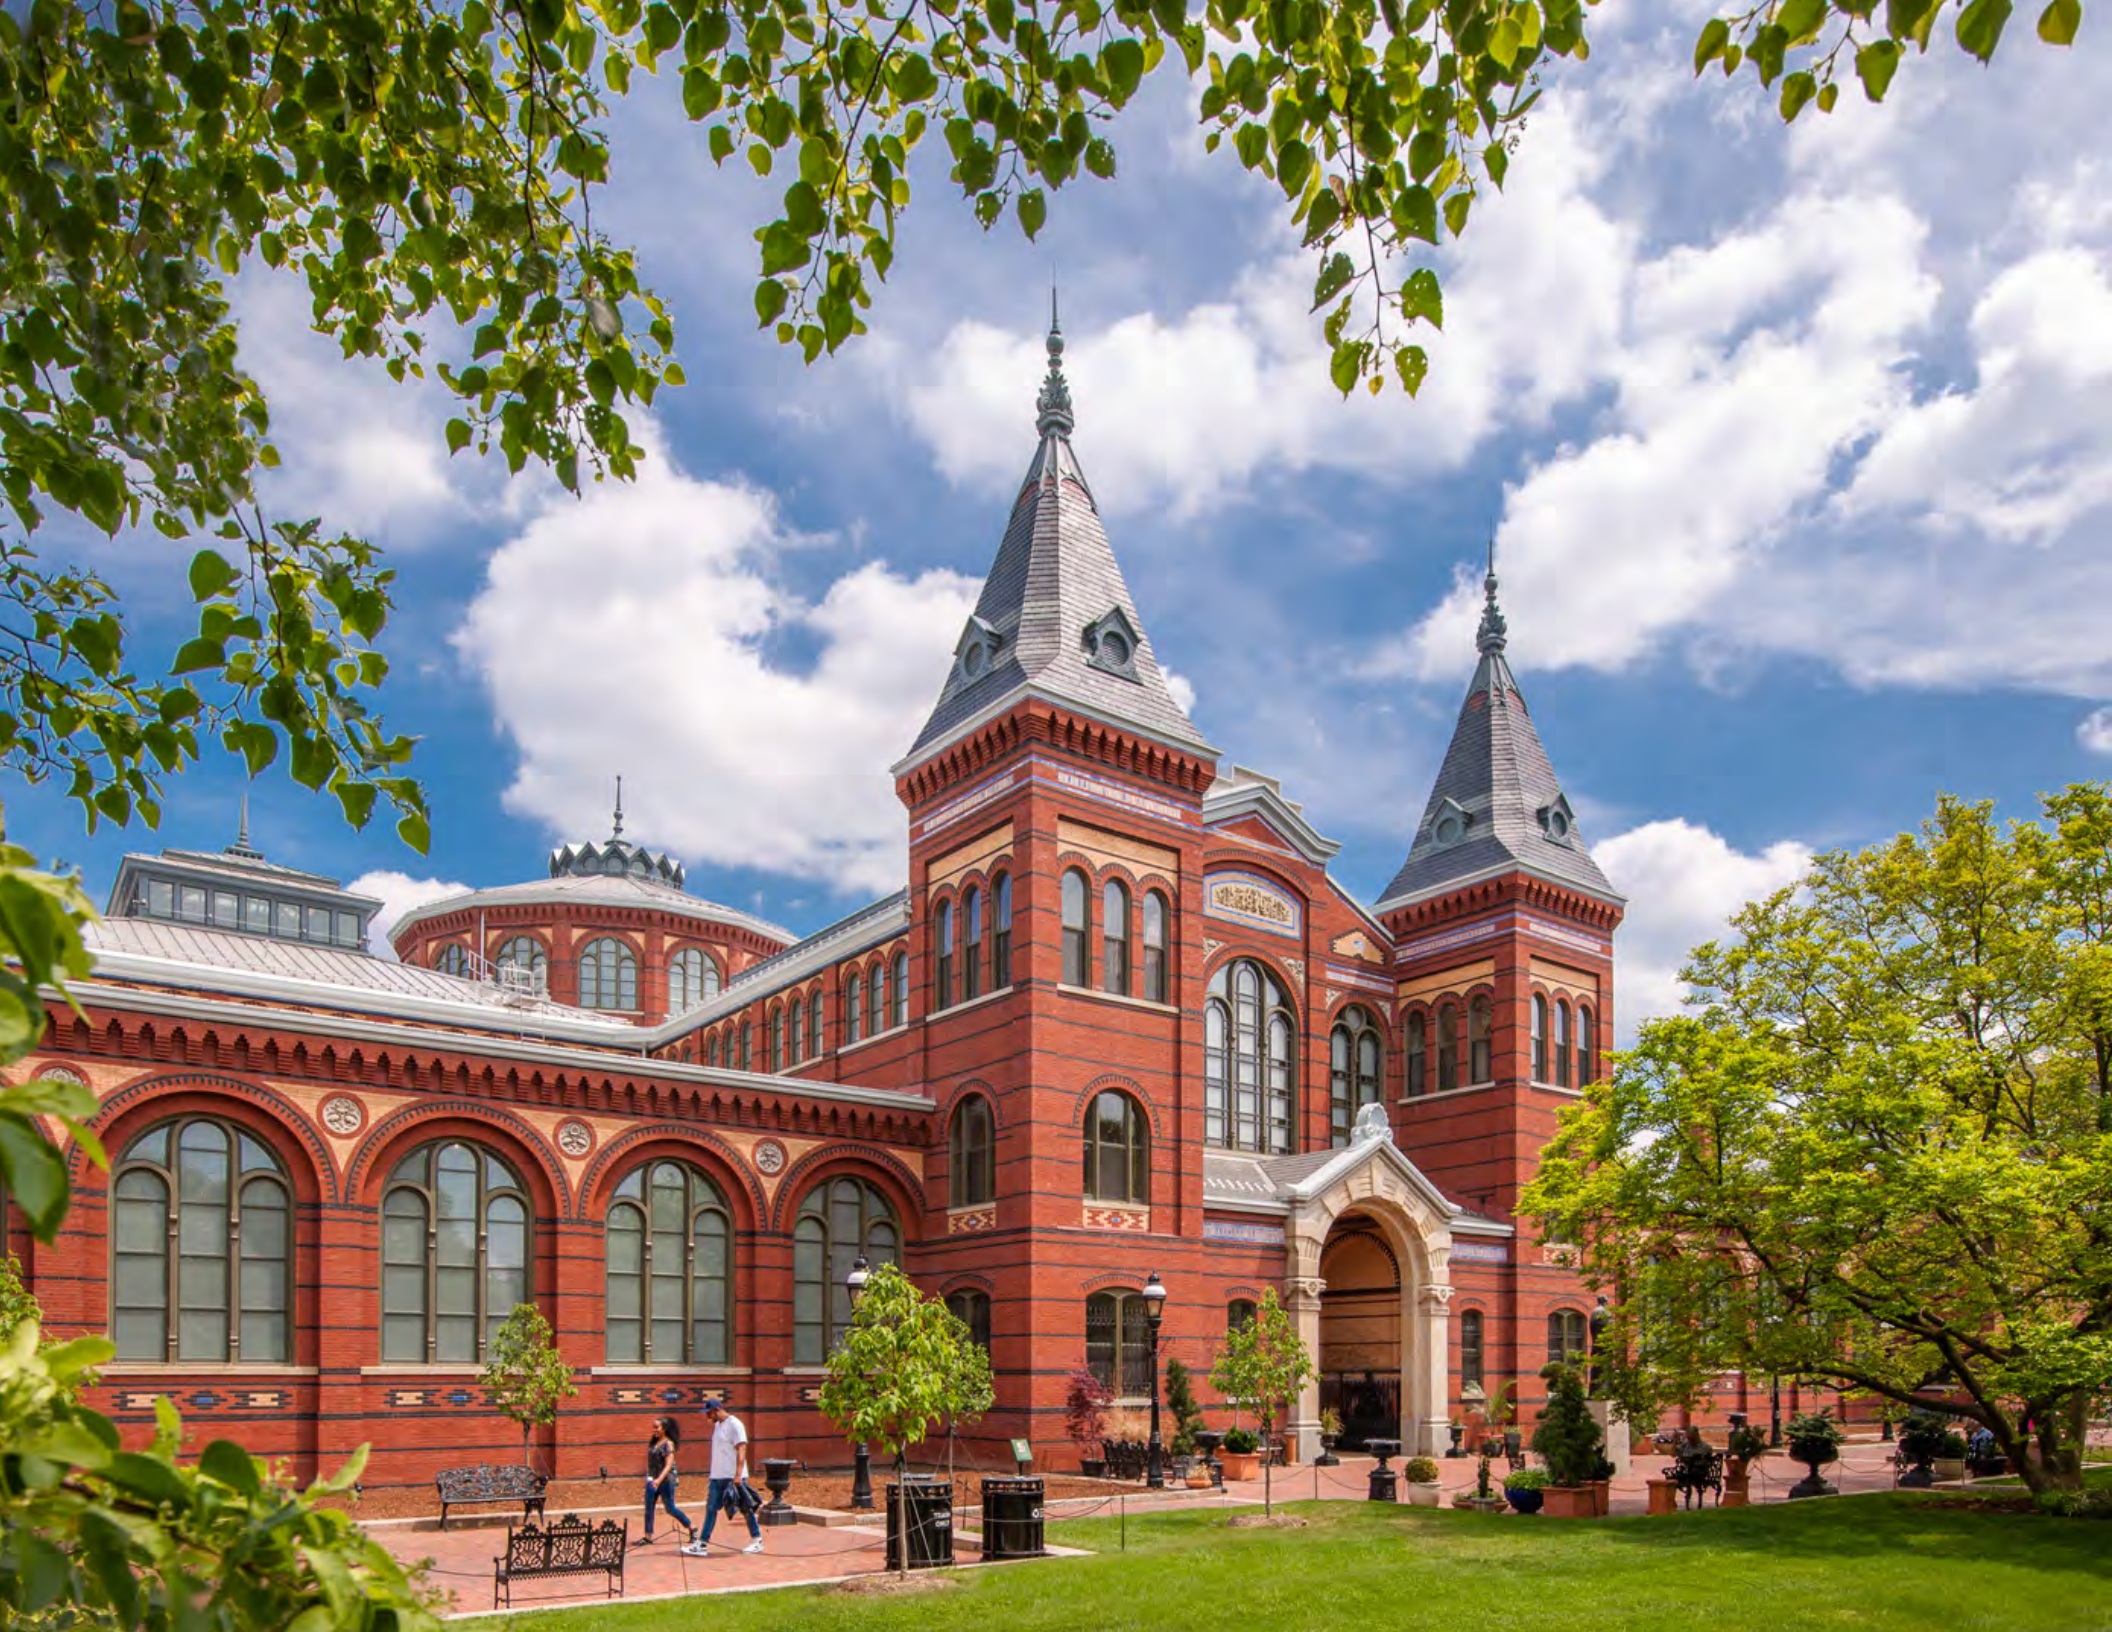
After North entrance from the National Mall looking southwest showing the various metal work, brick and stone cleaning, and the variety of window types. High performance organic coatings were used for all exterior surfaces requiring painting. The Burbel statue, which was removed, repaired and repainted, sits atop the north pediment.
