2016 AIA DC
Chapter Design Awards
Restoration of the Historic Watchbox
Washington, DC.

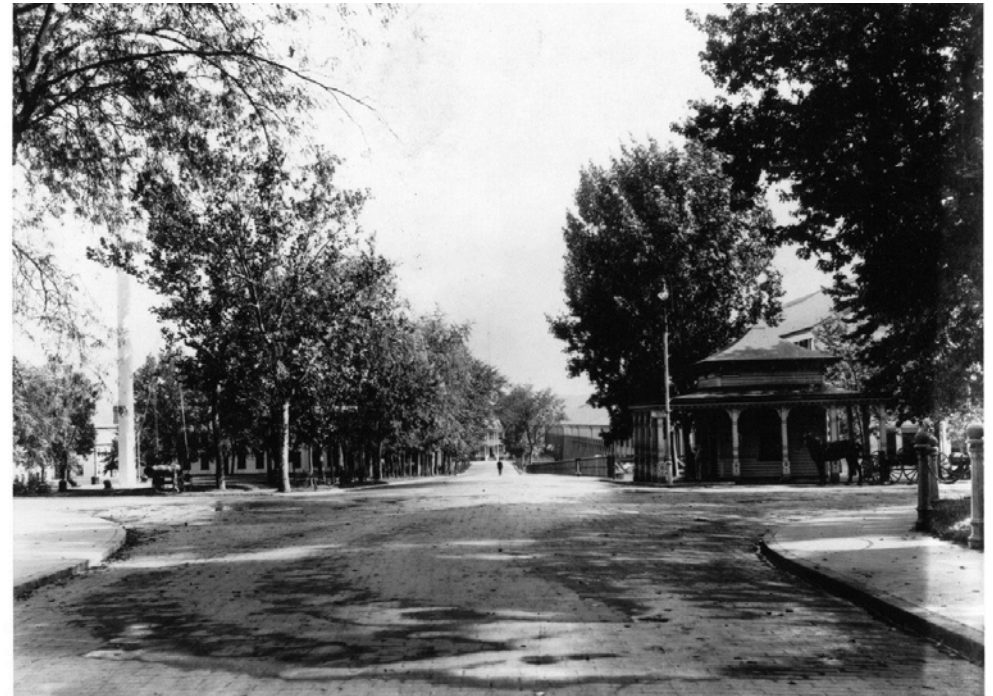
This higher level view, taken from the top of the Latrobe Gate (8th and M Streets SE) was critical to developing the detail for reconstructing the porch. The location of the Watchbox, actually projecting out into the road, was a point of discussion regarding the siting of the building.

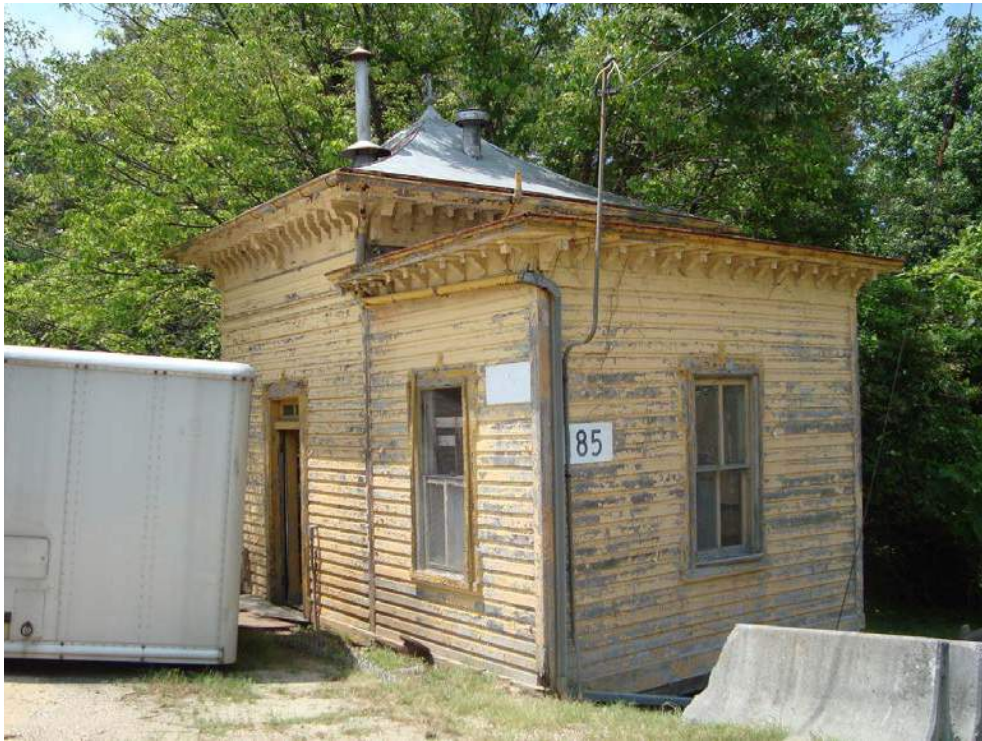
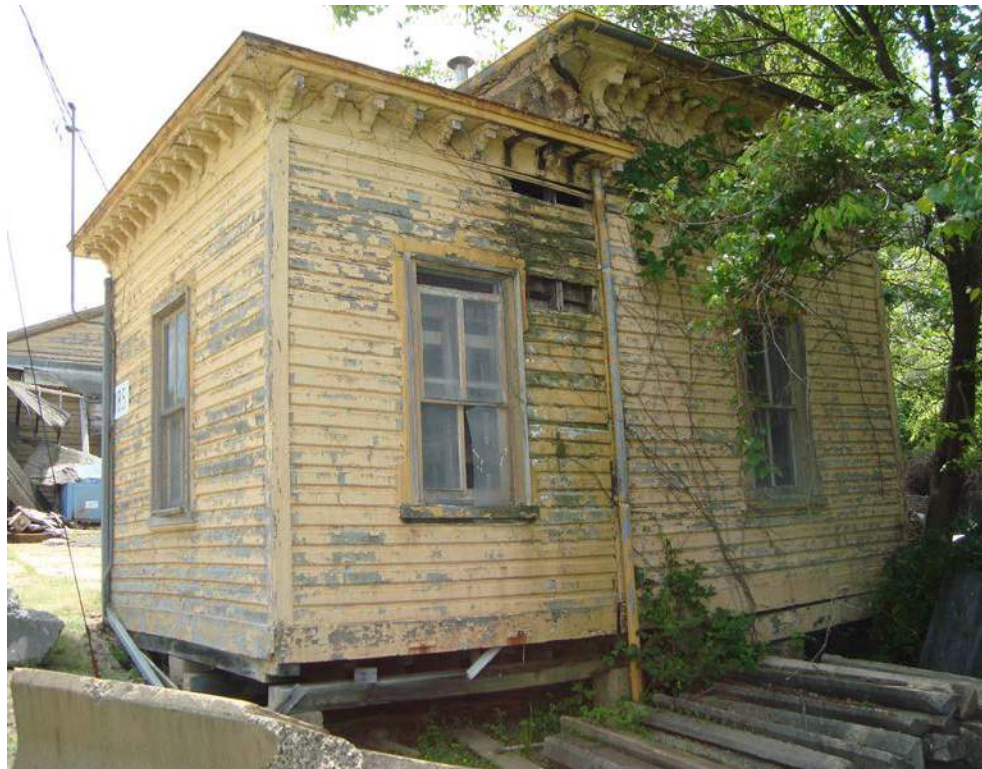
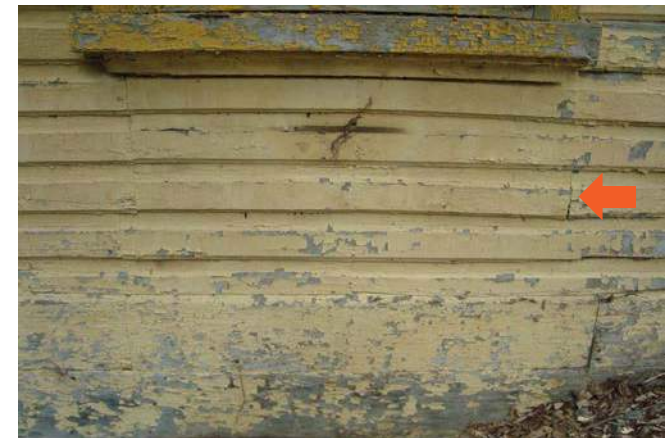
Door and window locations had been changed after the 1909 move. Evidence such as these splices in the clapboard were combined with photographs to recreate the original fenestration pattern.

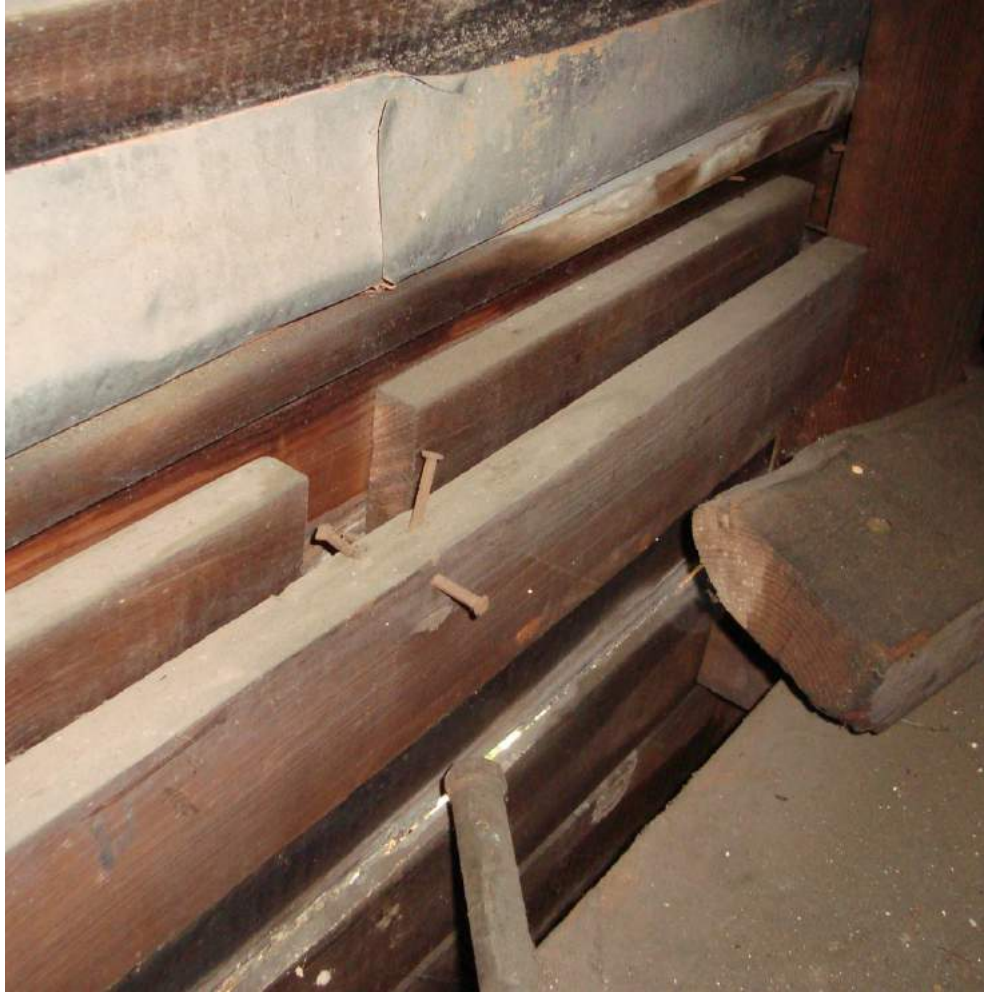
While the porch had been removed in 1909 the locations of the porch roof rafters were determined by these notches and cut nails that were used to secure the rafter ends.

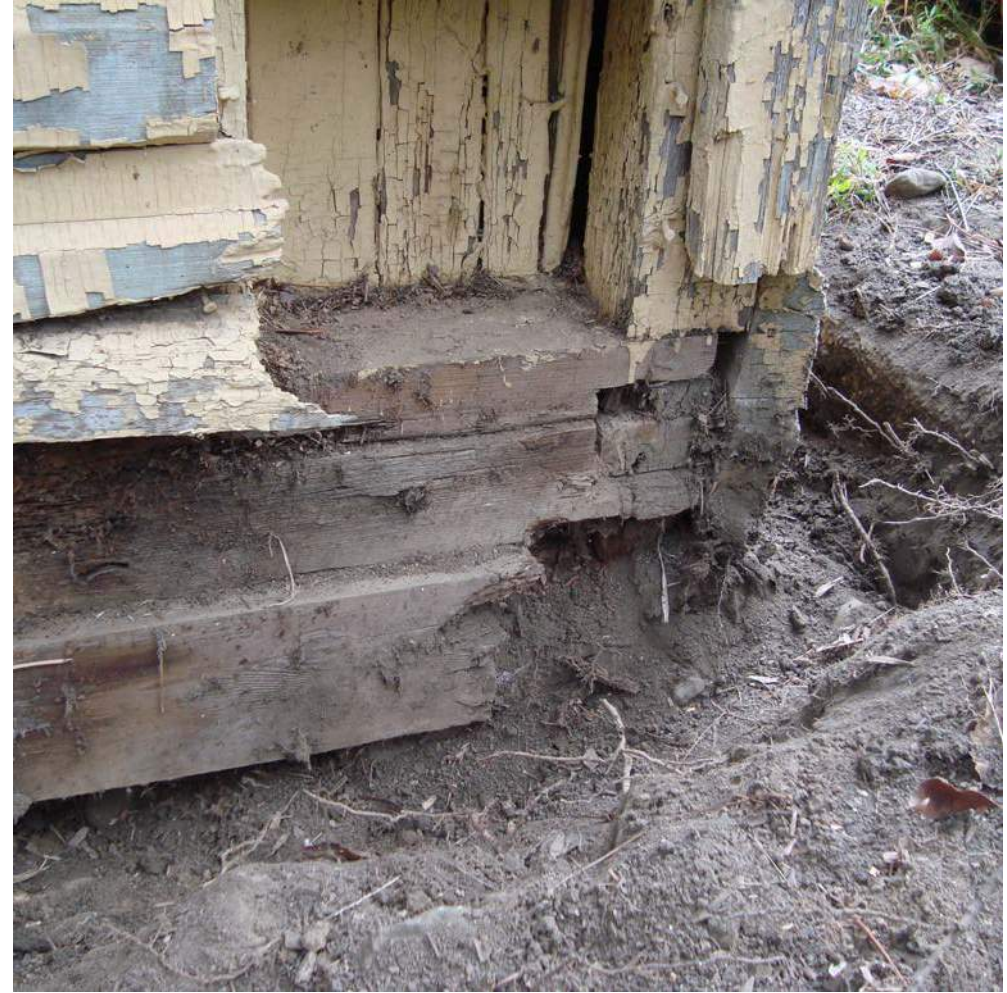
Investigation of the floor framing compared to the historic photographs lead the team to determine that the wood joists and flooring were not original and that the original construction included a brick or stone floor.

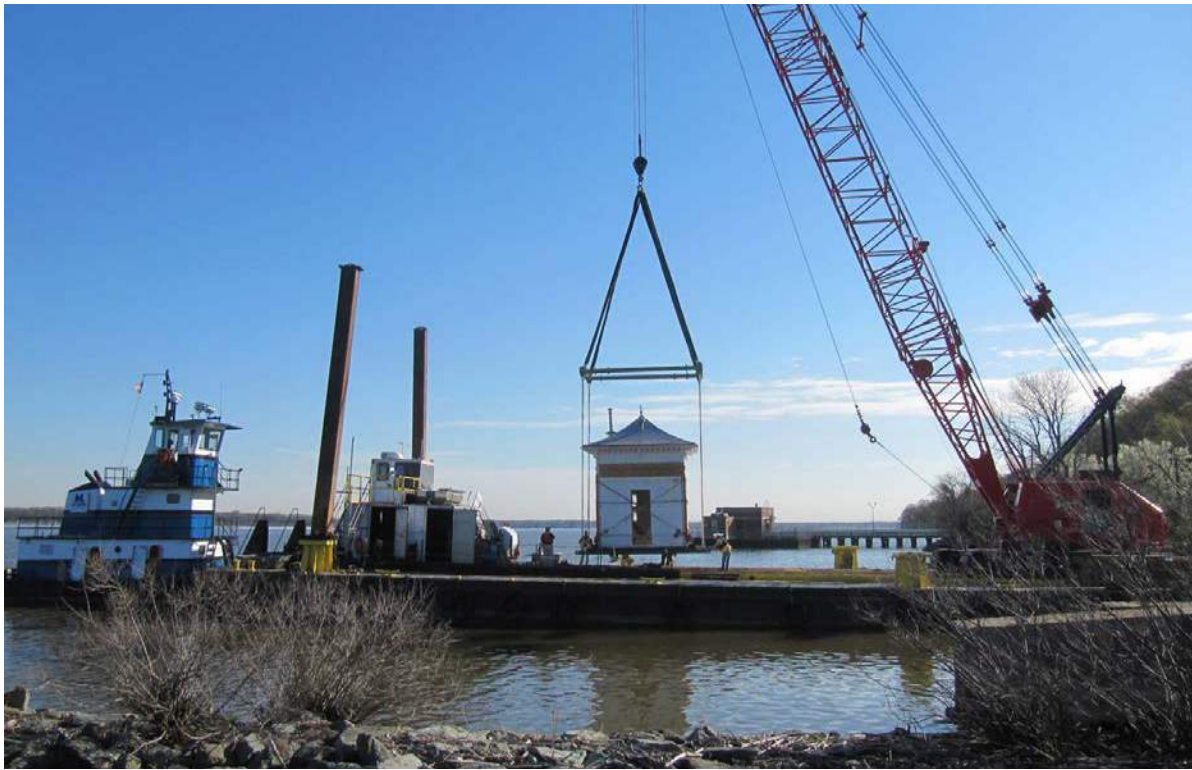
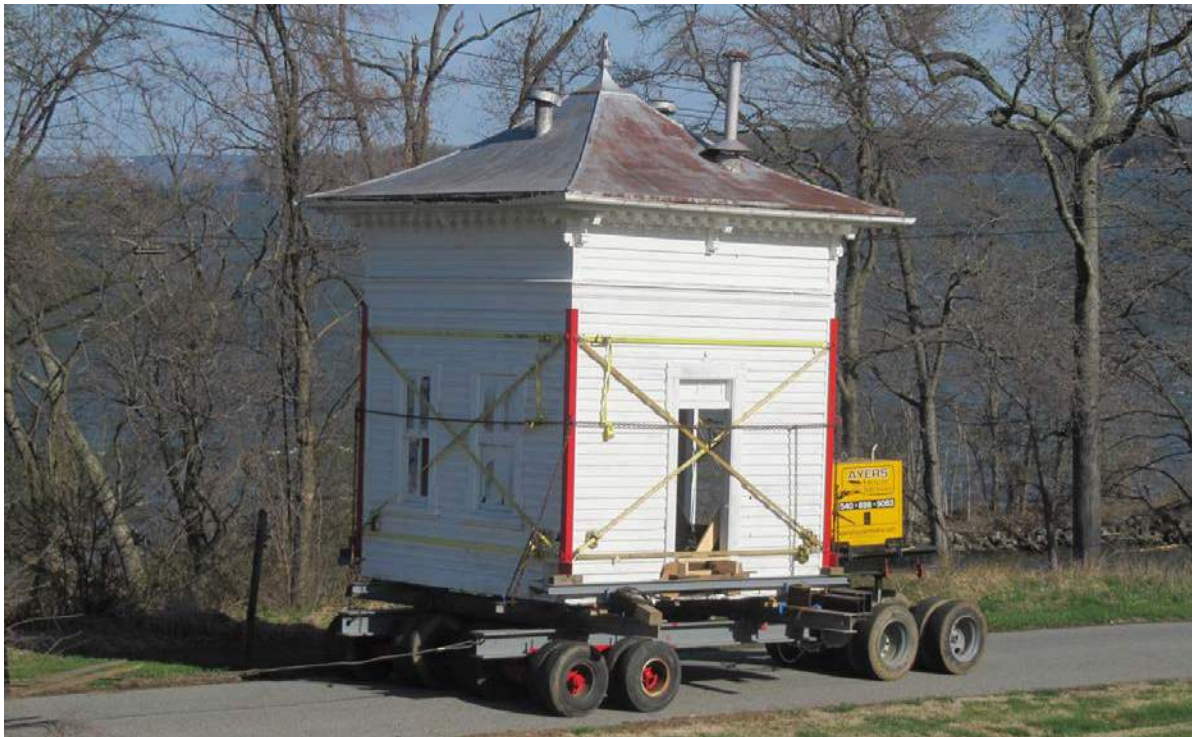
The Watchbox was braced and reinforced to prepare it for the move back to the Navy Yard. While the technology of moving a building is much more sophisticated today the route was very similar to the one taken in 1909. A construction barge was used to bring the building up river and motorized wheel sets carried it from the Navy Yard docks to the new foundations.

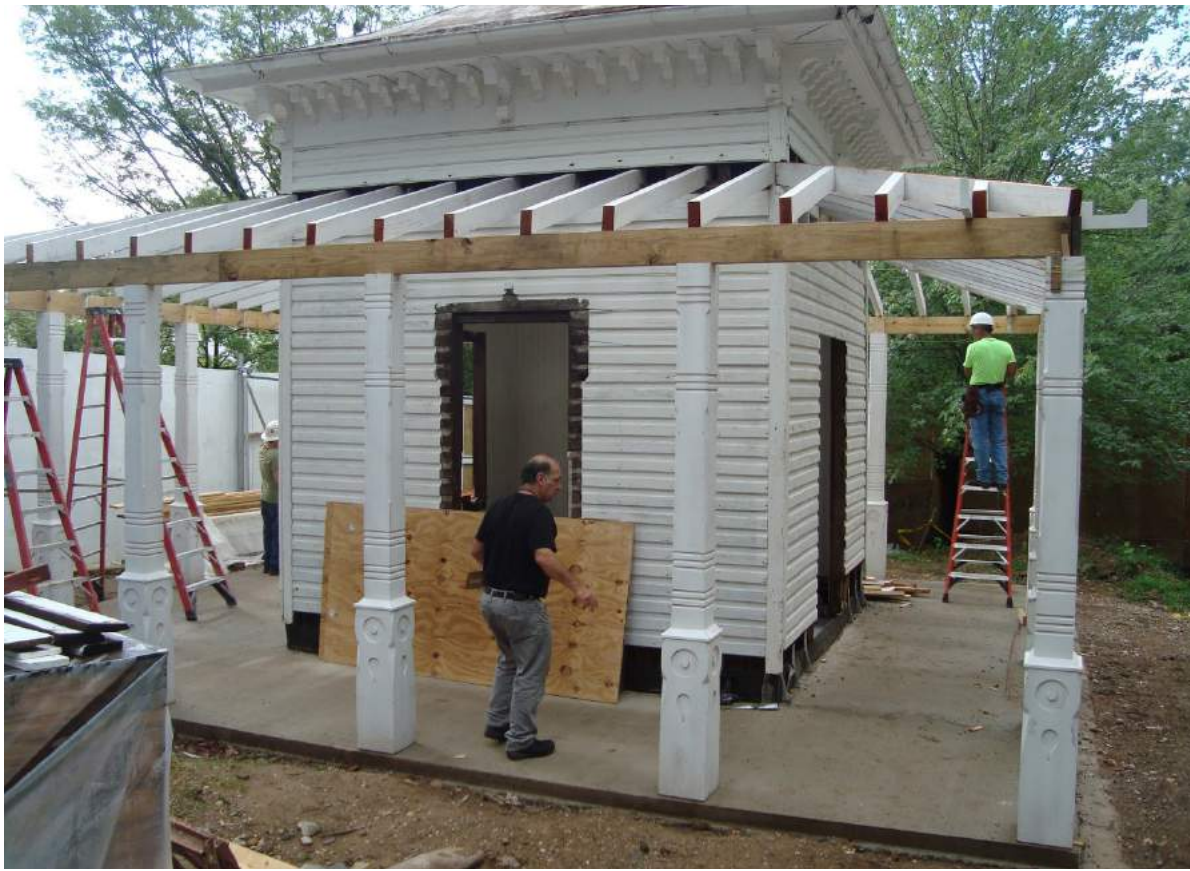
The construction drawings were developed in Revit to help the design team visualize how the reconstructed porch would connect to the historic core of the building. These diagrams simplified the translation of the work from documents to construction in the Design/Build project delivery.

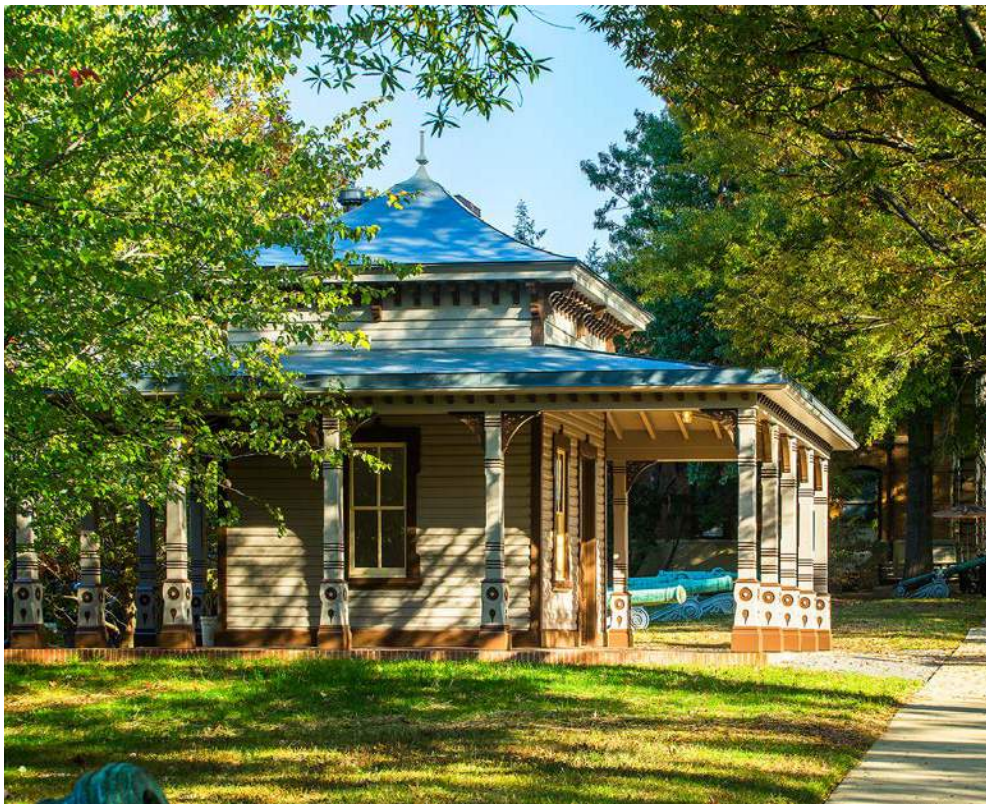
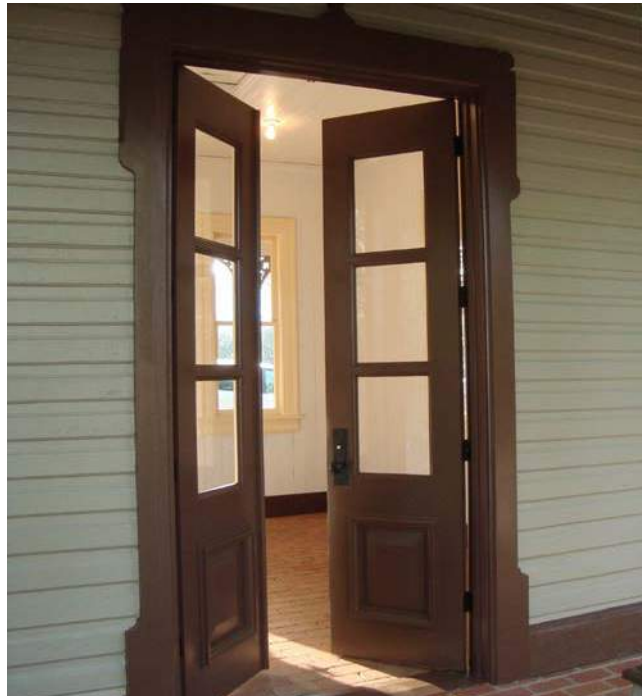
Completion photos showing the exterior including the reconstructed porch and the one-room interior with the brick floor. The view at the top is looking north towards the Fire House, which occupies the original site of the Watchbox.
